February 28, 2022

RECOMMENDATION TO THE

BOARD OF EDUCATION

FEATURES OF THE 2022 BOND PROGRAM RECOMMENDATION

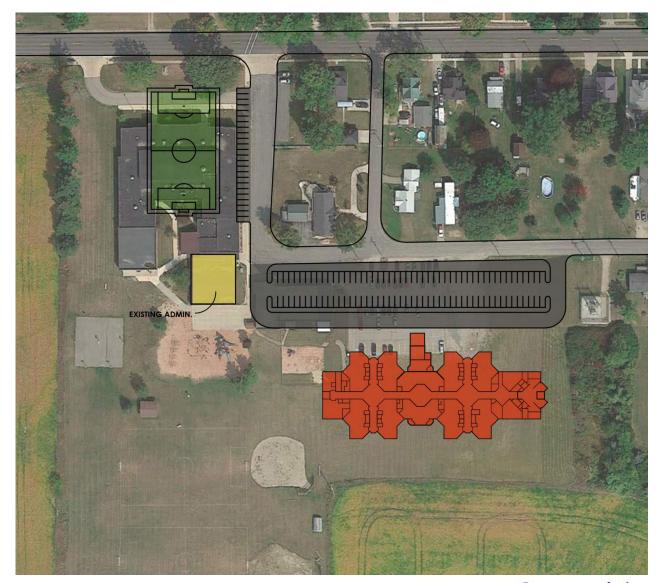
Possible concept for new Early Childhood Center. Further input will be sought from Community during March and April to determine actual location.

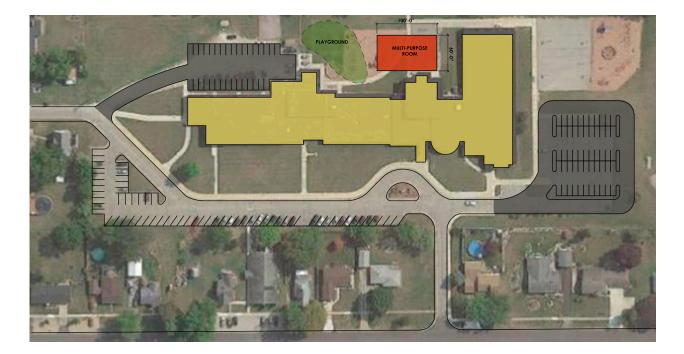
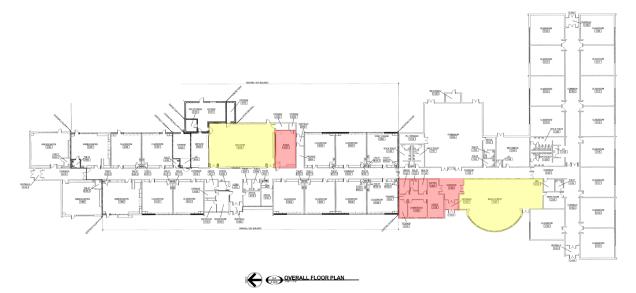
Elementary School

- New Safe and Secure Entry
- New Welcome Center
- Renovate Cafeteria, including Stage
- Library Upgrades and Furniture
- Build Multi-purpose Addition
- Relocate Playground
- Pave Staff Parking
- Reconfigure/Expand Auto Loop to alleviate Traffic Back-up on Washington Ave.

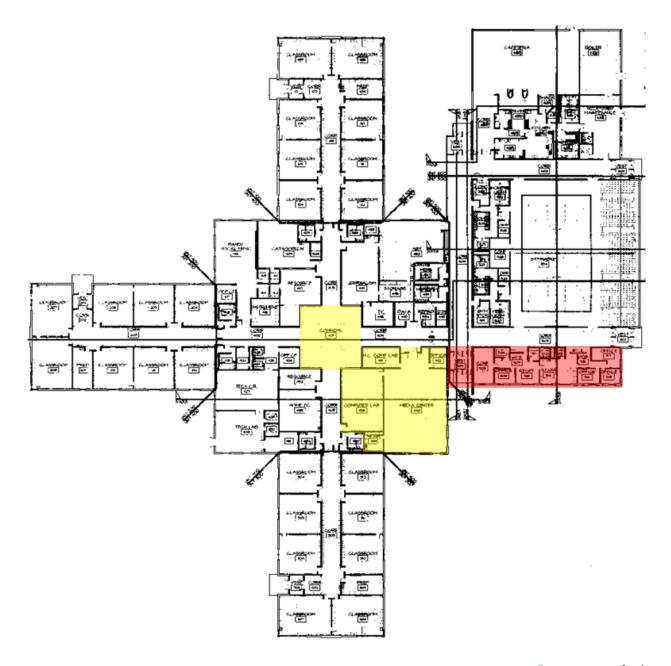
Middle School

- New Safe and Secure Entry
- Remodel Administration
- Library Upgrades and Furniture Remodel Common Space

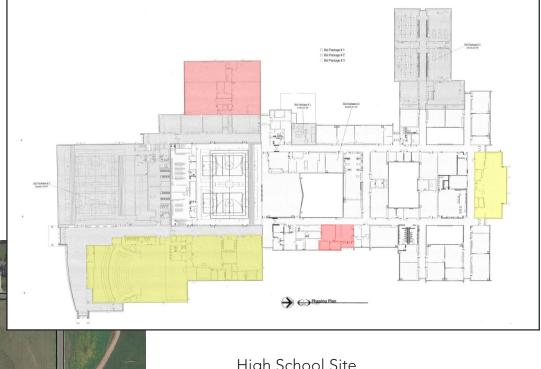
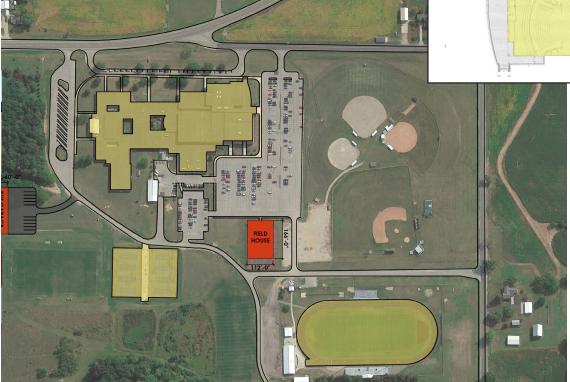
High School

- New Safe and Secure Entry
- New Welcome Center
- Library Upgrades and Furniture
- Upgrades to Music Rooms and Auditorium
- Upgrades and Repurposing of Wood and Auto Shop

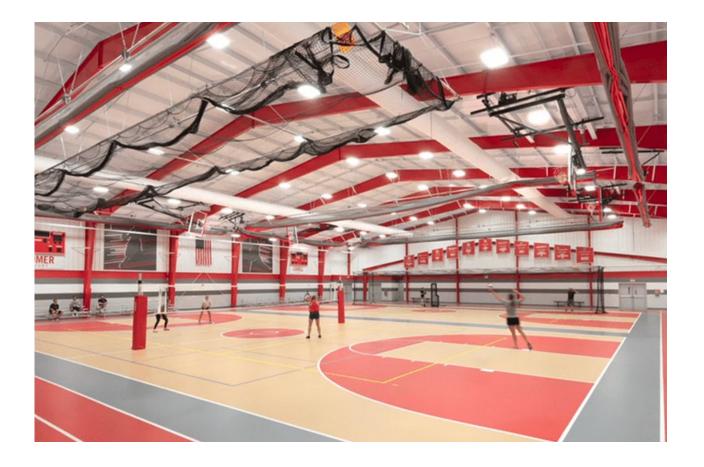
High School Site

- Track Replacement
- Synthetic Turf Football/Soccer Field
- New Fieldhouse
- New Bus Garage
- Tennis Court Upgrades

- Multi-Sport Practice Facility Community Fitness Center
- Youth Programs
 Walking Track
 Bathrooms

- Lockers
- Office
- Storage

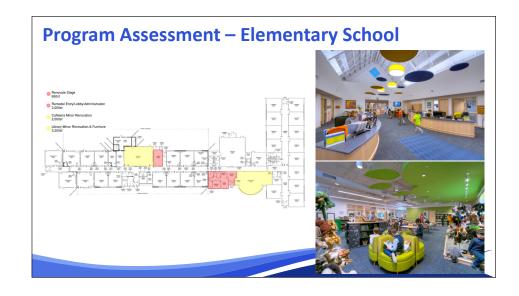
Elementary School Site

- New multi-purpose room addition provides opportunities for:
 - elementary physical education instruction in a gym setting rather than the cafeteria
 - large group instruction space for entire grade levels
 - after-school and evening community meeting space
- Reconfigured and larger parking areas to alleviate traffic backup on Washington Ave during drop off and pick up times
